RECOMMENDATIONS ON EMERGENCY AND RESTORATION WORKS OF WATER SPRING STRUCTURE 1 ON THE CHORNY TASHLYK RIVER IN THE CITY OF NOVOUKRAINKA

The article provides recommendations for emergency restoration work on the spillway structure on the Chorny Tashlyk River in the city of Novoukrainka. The problem statement and survey facts that affect the operation of the spillway structure are presented in detail. The characteristics of the hydraulic structure and the Chorny Tashlyk River are given. A list of defects is presented and the category of the technical condition of the structure is determined. The technical condition of the supports is determined and the category of their technical condition is determined. Two options for restoring the hydraulic structure to its working capacity are presented. Consider in detail both options for restoring the hydraulic structure and present the sequential execution of the work. Detailed information about the Chorny Tashlyk River is provided, its main characteristics are given. The type of water regime of the river is given, a multi-year schedule of average annual flows at the Tarasivka post is presented. Flow indicators by year are given (the largest,

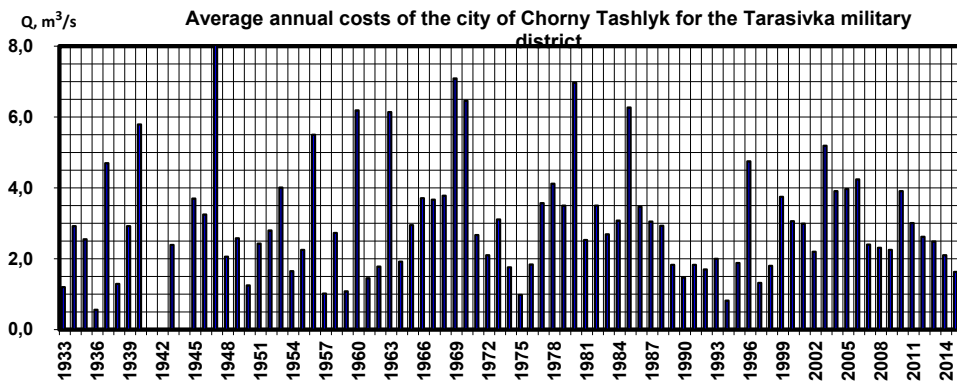
The multi-year schedule of average annual costs at the Tarasivka military post is shown in Figure 1.

Fig. 1. Average annual costs of the Chorny Tashlyk River on the Tarasivka military district

The river flow is uneven over the years. The average long-term flow in the section of the Tarasivka military post on the Chorny Tashlyk River is $3.18 \text{ m}^3/\text{s}$, in the section of the Novoukrainsk reservoir hydroelectric facility – $1.20 \text{ m}^3/\text{s}$. The highest average annual water flow was observed in 1947 – an average of $8.42 \text{ m}^3/\text{s}$ at the water meter station and $3.17 \text{ m}^3/\text{s}$ at the hydroelectric facility on the Chorny Tashlyk River.

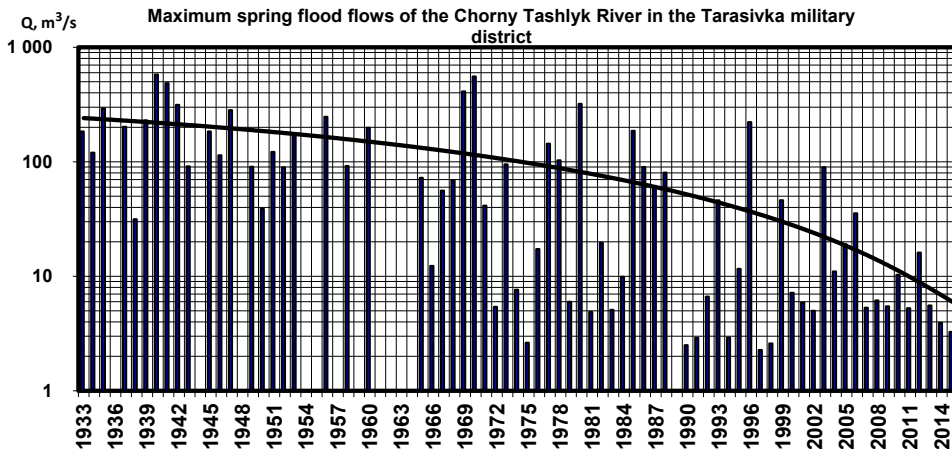
Characteristics of spring floods at the Tarasivka post-analogue are shown in the multi-year schedule of maximum spring flood flows – in Figure 2.

Fig. 2. Maximum discharges of spring floods of the Chorny Tashlyk River in the Tarasivka military district

The highest discharge during the peak spring flood period was observed in 1969 ($578 \text{ m}^3/\text{s}$), large floods (more than $300 \text{ m}^3/\text{s}$) were also in 1940; 41; 42; 70 and 1980. The last significant flood of $222 \text{ m}^3/\text{s}$ was observed in 1996.
