**CURRENT STATE, CHALLENGES
AND PROSPECTS FOR RESEARCH
IN NATURAL SCIENCES**

ECOHYDROLOGICAL INVESTIGATION OF PLAIN RIVER SECTION IN THE AREA OF SMALL HYDROELECTRIC POWER STATION INFLUENCE

Korzhov Ye. I.

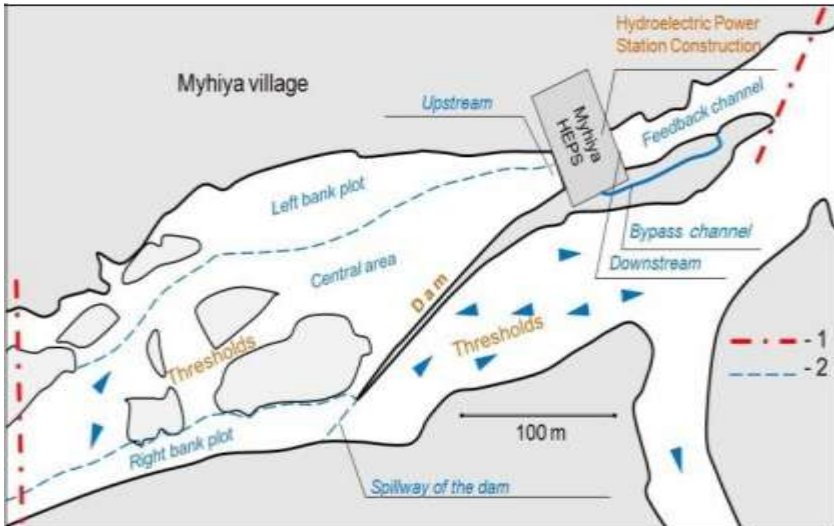
Fig. 2. The boundaries of the Myhiya hydroelectric power station influence zone (1) and the location of the water areas hydrological-morphological features (2)

Behind the hydrological indicators and morphological features, the zone is more likely to be divided into a number of woodlands, which, however, are almost different between themselves (Fig. 2).

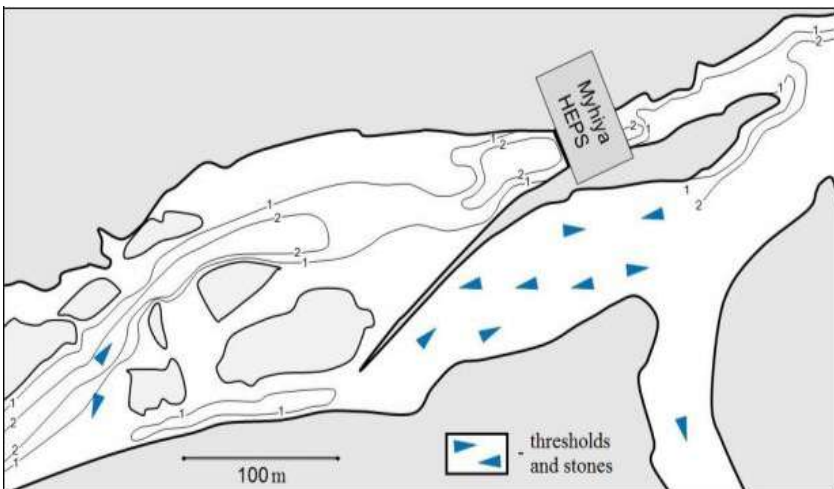
Fig. 3. Scheme of the area of e Myhiya HEPs influence in isobates (m) in the low hydrological season. According to the materials of full-scale shooting 18.07.2017

Investigations were carried out on the section of the Southern Bug River, 350 m above and 150 m below the structure of the Myhiya hydroelectric power station. Depth distribution in the studied area is rather uneven (Fig. 3).

The zone of maximum depths is located mainly in the central part of the study area and just before the hydroelectric dam. Depths here in the period of boundaries are 2.0–2.6 m. The rest of the dam above is shallow. Along the left bank, the depths are 0.5–0.8 m, at the bottom a considerable layer of sludge with vegetable detritus. In the area of the dam and between the rocky islands, there is also a shallow zone with a range of values of 0.5–0.9 m. In this part, due to the high flow velocities, the bottom is represented by stones, pebbles on which various rheophilic species of higher aquatic vegetation grow.

In the lower side of the hydroelectric power station, the average depth is about 1.0 m. The greatest depth is noted near the oval tunnel, and, at a distance of 5 m from it, on the day of observations was 2.5 m. Further along the channel, the depth rapidly decreases to 0.6–1.0 m. Due to the lack of water flow, the bottom is muddy, overgrown with water vegetation and clogged with tree fragments. At the point of exit of the water from the outlet channel at a distance of 55 m from the dam, the soil changes to muddy sand with shell detritus, well washed.

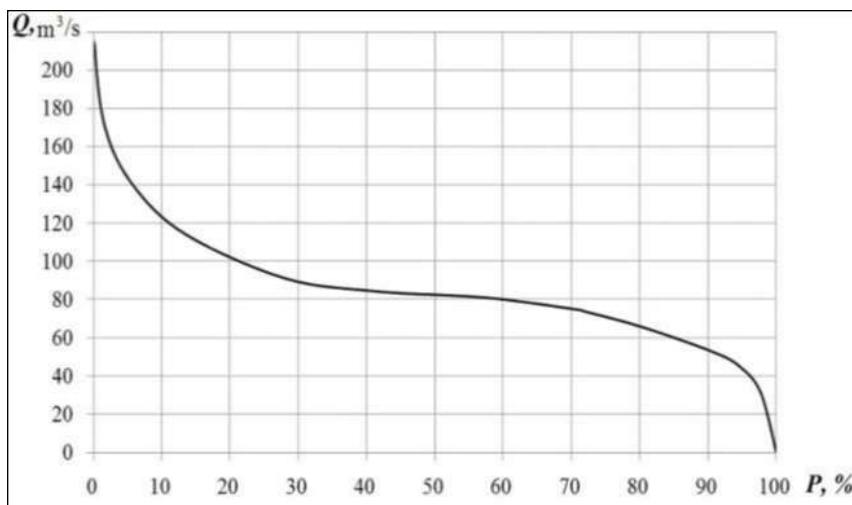
Fig. 4. Current water supply curve in the area of Myhiya village in the modern period. $Q_m = 81,9 \text{ m}^3/\text{s}$, $C_V = 0,39$, $C_S = 2 C_V$

According to the average annual water consumption, we have constructed a supply curve for the Southern Bug River in the region of Myhiya village (Fig. 4).

The variation coefficient of water flow in the area of hydroelectric power station (C_V) is 0.39, which indicates a moderate variability of river flow over many years. Based on the calculated values of Q_m and the coefficients of C_V and C_S , we obtained the values of average annual water flow in low-water, average water and high-water years under current conditions (Table 1).

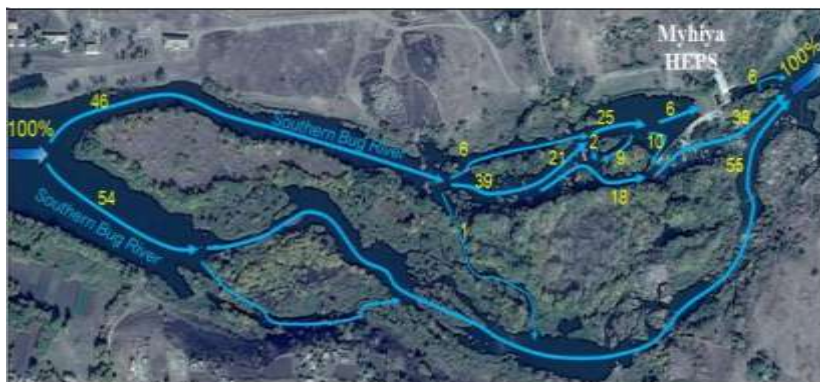
Fig. 5. Distribution of flow over the Southern Bug River water system in the region of Myhiya village in the low water period of the year. Figures on the diagram – the share of flow on a separate site in% of the total river flow (water consumption $43 \text{ m}^3/\text{s}$). According to the materials of full-scale shooting 18.07.2017

Based on the materials of field observations of water consumption for the investigated area, we constructed a scheme for the distribution of time in the Myhiya village in the low-water period (Fig. 5)

From the above materials it can be seen that under the current conditions (with the turbines not working), only 16% of flow from the total volume from which only a part is transported to the outlet channel reaches the hydroelectric station. The other 10% is lost as a result of the transfusion of the water through the dam (mainly in its outermost part) and other channels. Such a cost distribution in the upper stream, especially near the left bank, creates favorable conditions for the siltation and sedimentation of small fractions.

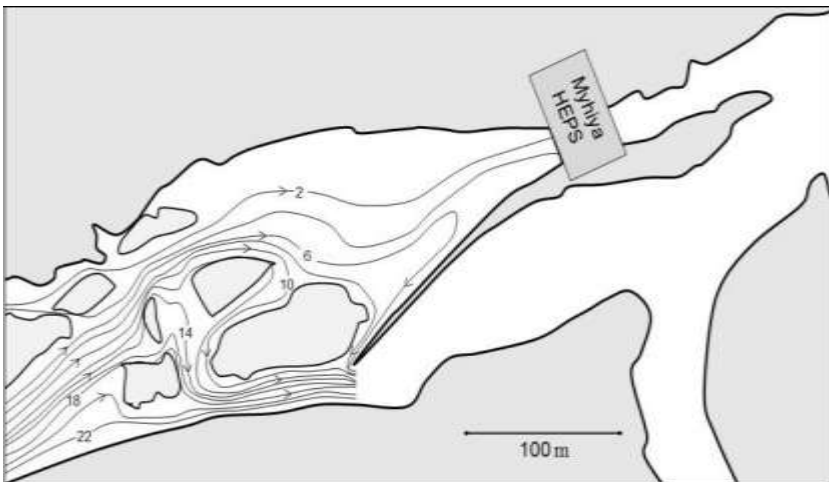
Fig. 6. Water circulation schemes in the area of influence of Myhiya HEPS under calm weather conditions (with turbines off). Current lines are given in m^3/s

Circulation patterns clearly illustrate how water flow is distributed along the water area and the main (summary) direction of displacement of water masses at a particular site of a water body (Fig. 6).

The results of mathematical modeling show that the most dynamically active section is the right-bank part of the object near the threshold exit and the far section along the dam. Under modern conditions (intermittent period, hydroelectric power turbines are switched off), water flows from the western part of the channel and flows mainly along the channels along the right bank. In the central part of the body of water, a large-sized stagnant zone is formed, which is located along the left bank and partly in the central part and extends to the dam of the hydroelectric power station. The velocity of flow in this zone, on the basis of full-time shooting materials, on 18.07.2017 averaged 0.03–0.08 m/s, in the central area it increased to 0.10–0.20 m/s, while in the area of the outlet of the stream through the dam at the thresholds of the flow increased to 1.20–1.40 m/s. Such heterogeneous distribution of flow velocities over a relatively short distance causes the formation of different types of biotopes coexisting in a small area. Along the left bank, mainly water flows, which are then diverted to the hydroelectric turbines, and the volume of this water depends on the capacity of the hydroelectric power station. Therefore, in order to increase the flow in the congested areas, an effective measure may be to pass more water through sewage and bypass channels, which will cause additional water supply to the left-bank and central sections of the water area and significantly improve their ecological status.

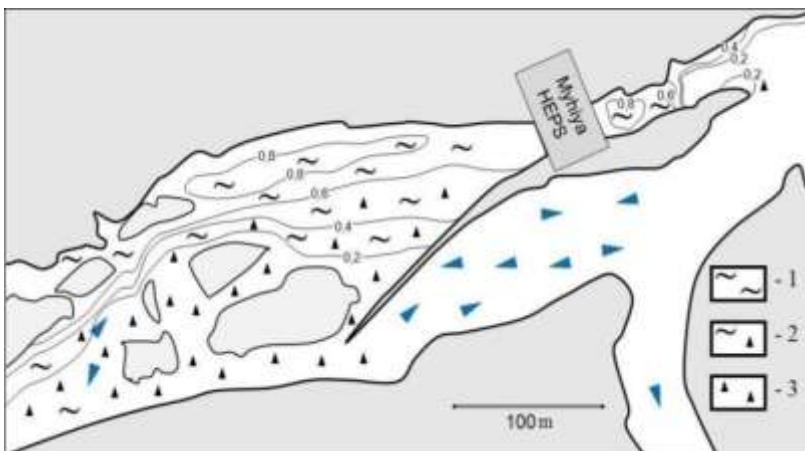
Fig. 7. Scheme of distribution of bottom sediments in the area of Myhiya HEPS. The figures show the sludge capacity in meters. 1 – organically saturated silt, 2 – silt on stones, 3 – pebbles, stones

The distribution of sediments is in good agreement with the position of stagnant and flowing sections of the water circulation scheme (Fig. 7).

Above the hydroelectric power station, the highest silt capacity is recorded along the left bank. The maximum capacity of the sludge layer here is 0.8 m. The average particle diameter of the solid sludge fraction in the impact zone is 0.05 mm. Then it gradually decreases in the direction of the right-bank part of the study area, where the bottom sediments consist mainly of pebbles and stones.

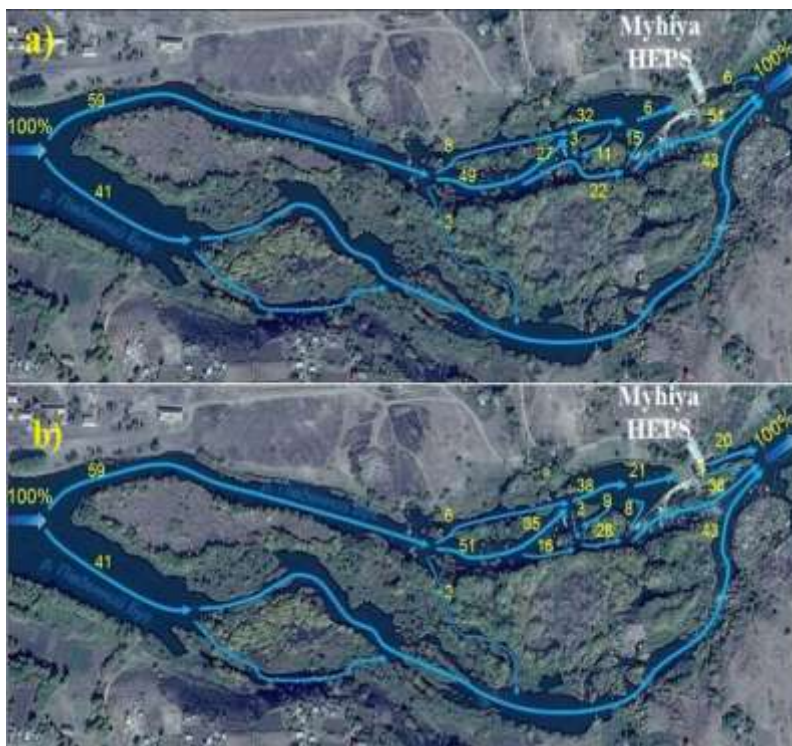
Fig. 8. Changes in the distribution of flow on the water system in the area of the Myhiya hydroelectric power station after its introduction

Flow distribution: *a)* – before start of hydraulic turbines (18.07.2017),
b) – after start of hydraulic turbines in 2017 (23.07.2018)

After the hydroelectric power station was restored, there was some redistribution of flow over the water system of the investigated section of the Southern Bug River (Fig. 8). In the area above the dam, water consumption increased in the area of the left bank and in the central part of the water area.

Due to the operation of the hydroelectric turbines, the flow to the downstream has more than tripled and now accounts for 20% of the river's flow. The increase in the water content of this section was due to the decrease in the flow rate of water that had previously passed the thresholds. If, according to the data taken on July 18, 2018, 51% of the water from the total flow of the Southern Bug River flowed through the thresholds, then after the start of the hydroelectric power station the water consumption here decreased by 15%.
